Date: October 16, 2019

Subject: **Investigative Report**
Amusement Ride Reopening Requirements
Amusement Ride: Giant Gondola Wheel
PA Ride ID Number: 2660
7 PA Code § 139.11(c)(2)

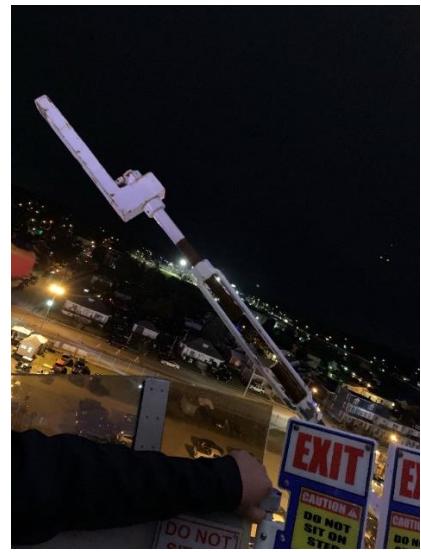
Rider 1 and Rider 2 noted that a large metal bar (part of the structure of the Wheel) became detached at one end of the Wheel and swung to the side of Gondola 1 just prior to the accident. Both stated that they called out repeatedly to the operators during the last rotation of the Wheel just prior to the accident. Rider 1 took a photograph of the metal bar near the top of the Wheel, see **Fig. 2**.

- The tie rod (described as the metal bar by Rider 1 & 2 and pictured in **Fig. 2**) is designed to be held in place by a pin and hairpin (a.k.a. r-key, "Hairpin" is Chance's terminology used in the manufacturer owner's manual), commonly known as a pin and r-key.

Fig. 2 – Loose tie rod photographed by Rider 1

- The tie rod came loose before the gondola was locked in place. This is detailed by several witness accounts and photographs. See **Fig. 2** and **Fig. 7**.
- Documentation showed that the Wheel was inspected by Warble as required by the Department¹ prior to opening of the ride. Additional documentation showed that the Wheel was inspected daily by Deggeller.
- The location of the connection points for the tie rod to the sweep is not easily accessible and it is unlikely that pins or Hairpins were removed accidentally or intentionally. See **Fig. 3**, **Fig. 4**, and **Fig. 5**.

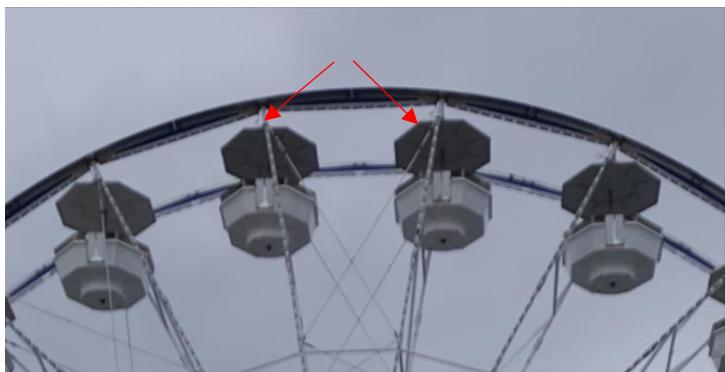
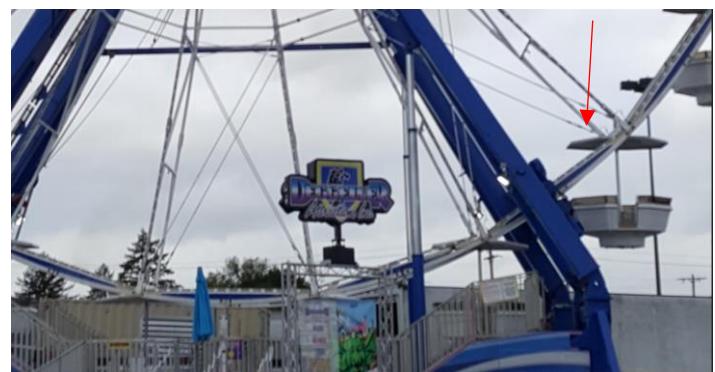
Fig. 3 and Fig. 4 – Tie rod connection points not easily accessible by patrons.

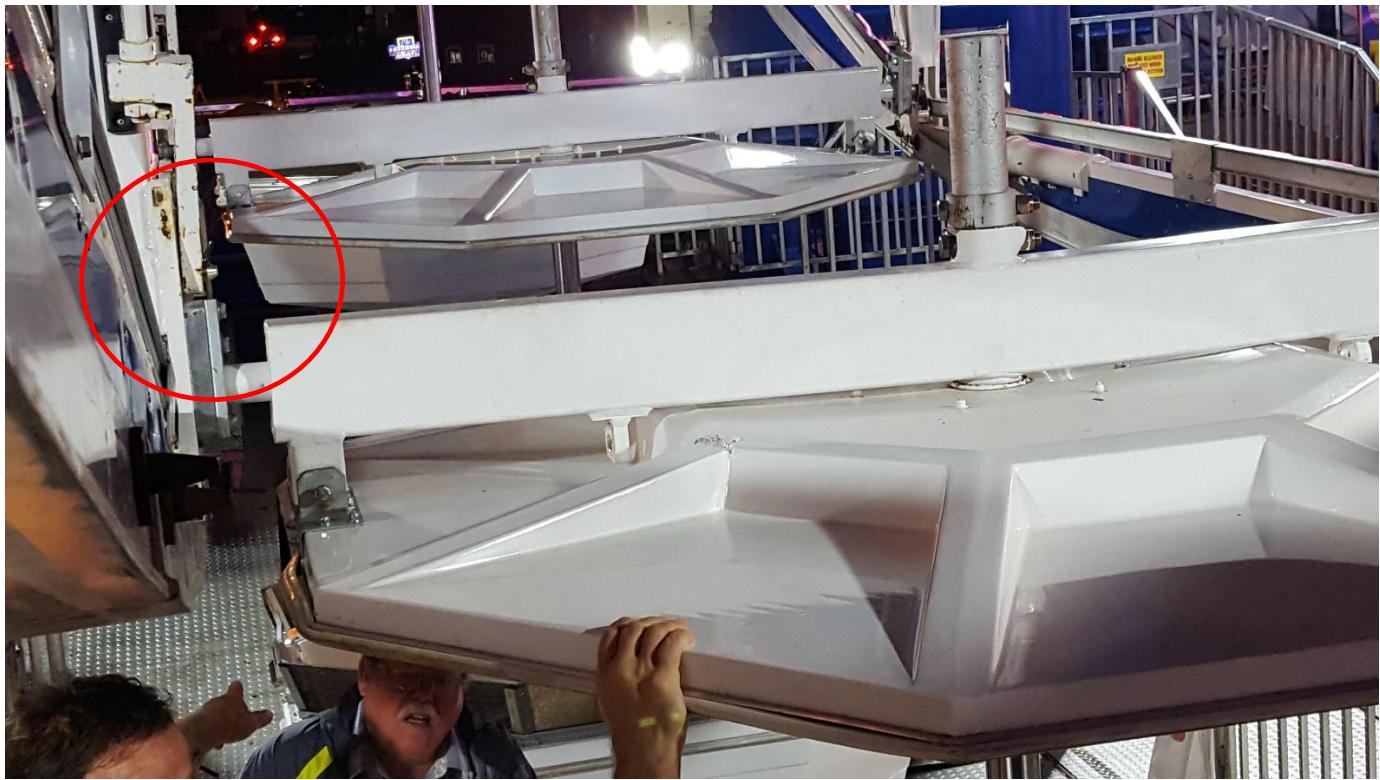
- The tie rod pins are located away from patrons and are located next to the bearing block for the T bar to which the gondolas are mounted. There is very little room between a Hairpin and the bearing block. If the pin rotates, a sprung Hairpin could contact the bearing block. See **Fig. 5** and **Fig. 6**.

Fig. 5 – Tie rod pins location away from patrons and are very close proximity to bearing block.

- The Wheel has the tie rod pins installed from the outside pointing in toward the center. This places the hairpin close to the bearing block.
- Three of the other Giant Gondola Wheels inspected by the Department had the pins installed from the inside pointing out (this configuration places the Hairpin away from the bearing block and away from possible tampering).

- Pin installation. The Department has noted the discrepancies in the proper installation of pins as they relate to the tie rods. As part of the reopening requirements Deggeller will need to confirm and adhere to Chance's pinning requirements.

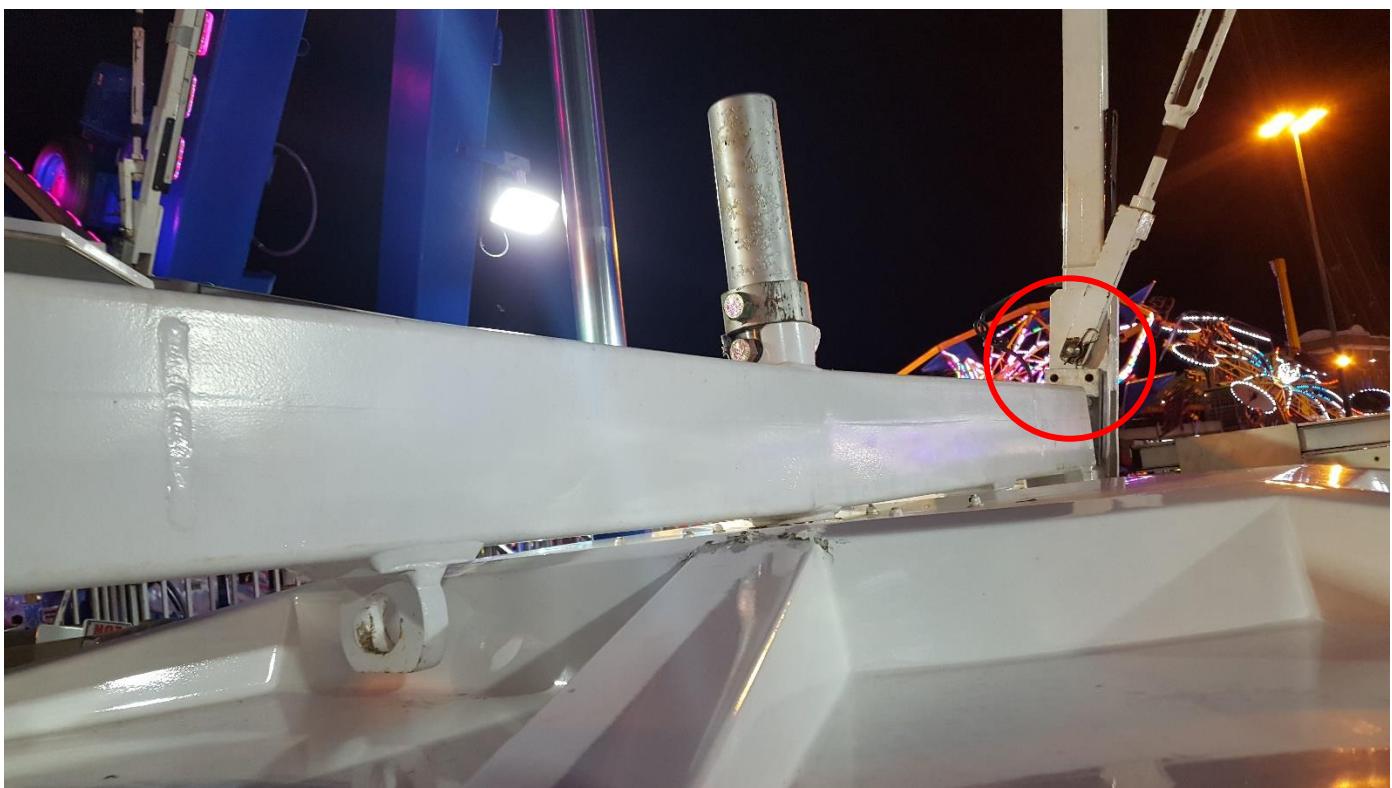
Fig. 6 – A tie rod pin connection is shown, note how close the Hairpin is to the bearing block

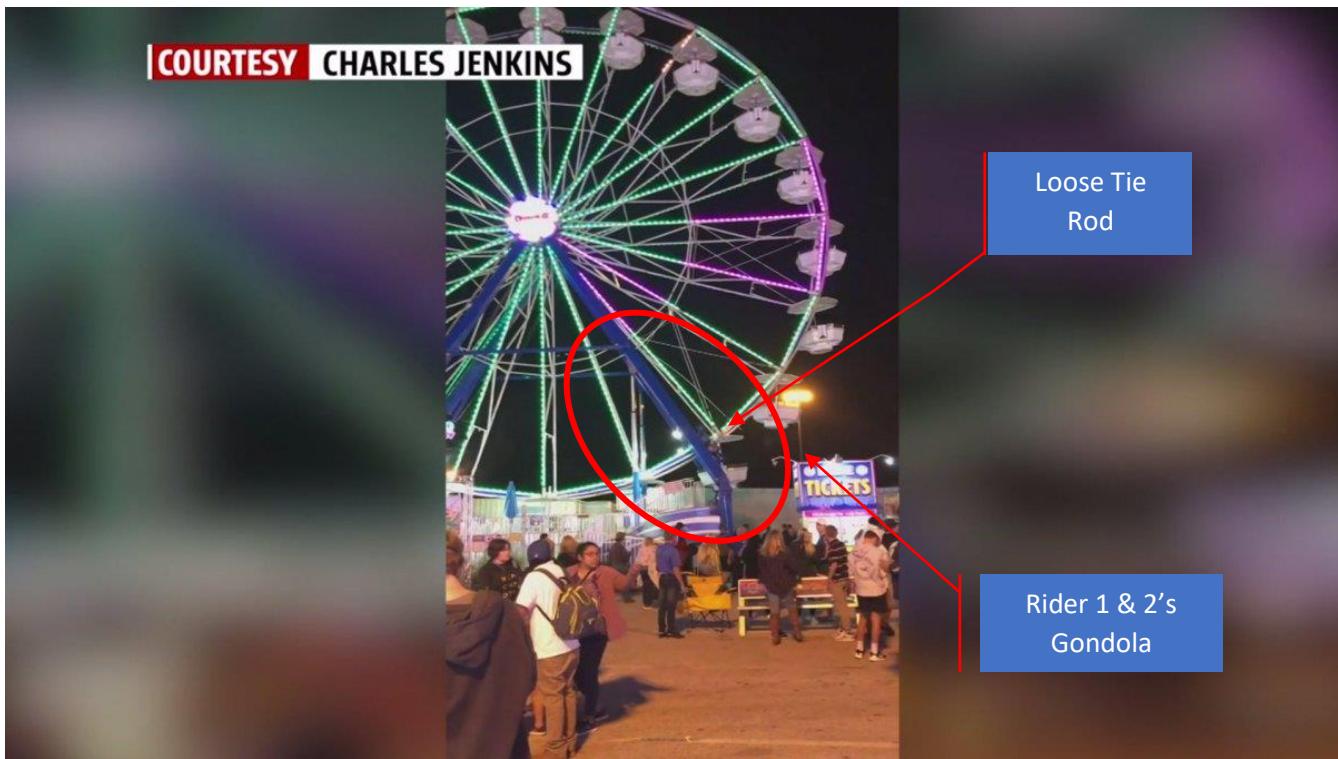
- Gondola 1 was jammed in place during the accident, which caused it to tip (fail to swing freely and maintain an upright position while the wheel rotated) after a loose tie rod contacted the canopy (bonnet) of the gondola.

- Local media assisted by providing a bystander's video of the ride after the accident. Please note the captured still picture from the video details the loose tie rod that caused Gondola 1 to tip. See **Fig. 7**.

Fig. 7 – The Wheel shortly after the accident, note the loose tie rod

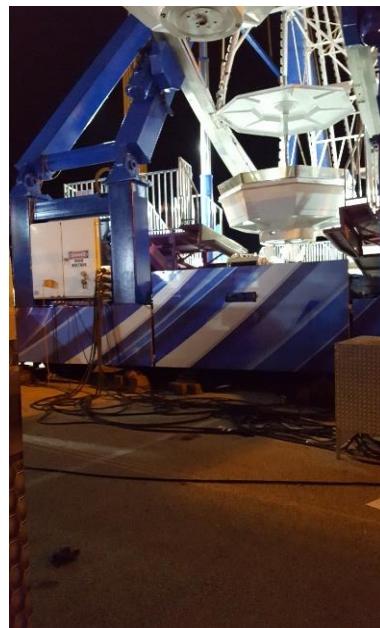
- Rider 1 fell out of the gondola as the gondola was stuck in a position that was 90 degrees from normal (almost parallel to the deck) as it rotated through the station area. The Wheel travels a portion of a rotation to stop, which accounts for Rider 1's fall of approximately 25 feet as the Wheel slowed to stop. Rider 1 was said to have landed on power cables and asphalt. See **Fig. 8**.

Fig. 8 – The area on the side of the wheel where Rider 1 landed

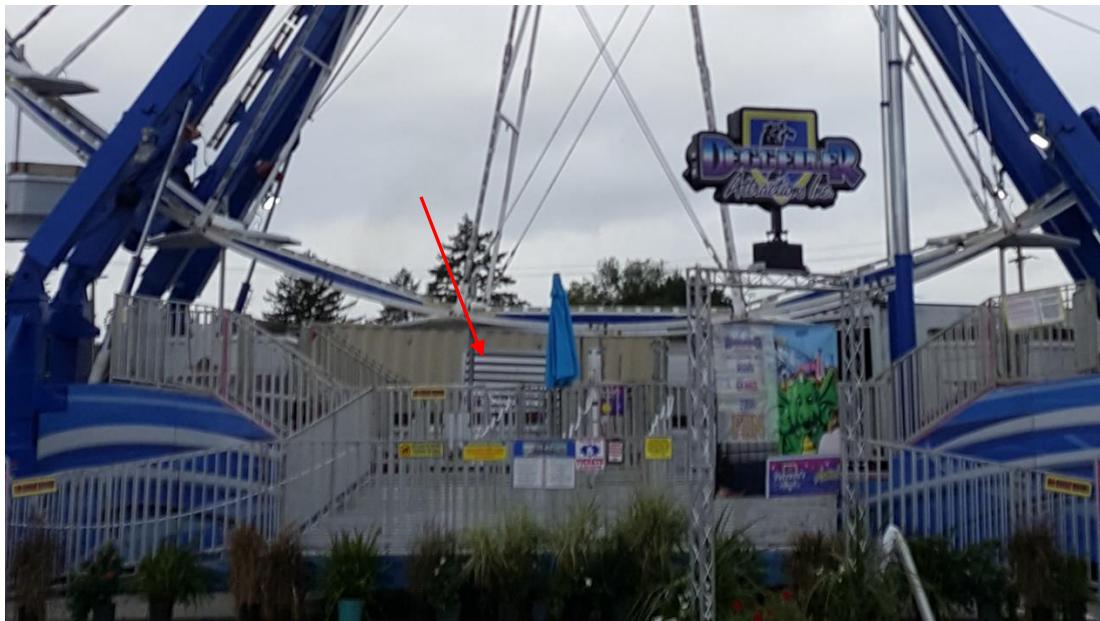
- The generator power plant for the midway was located behind the Wheel. The noise from the power plant may have been enough to hinder communication between the operators, assistants and patrons. Riders 1 & 2 emphasized that they attempted to shout to the operators prior to the accident. The power plant was in operation during the investigation and the noise was as described by Riders 1 & 2 and made it difficult to communicate during the investigation. See **Fig. 9**.

Fig. 9 – Notes the location and proximity of the power plant to the Wheel. The slats shown are to let air into the power plant but also do little to muffle the noise of the power plant

- Operations.** The power plant's proximity to the Wheel and noise level may have inhibited the operators from identifying the danger of the tie rod as it broke free from the Wheel's superstructure and the subsequent calls from Riders 1 & 2.

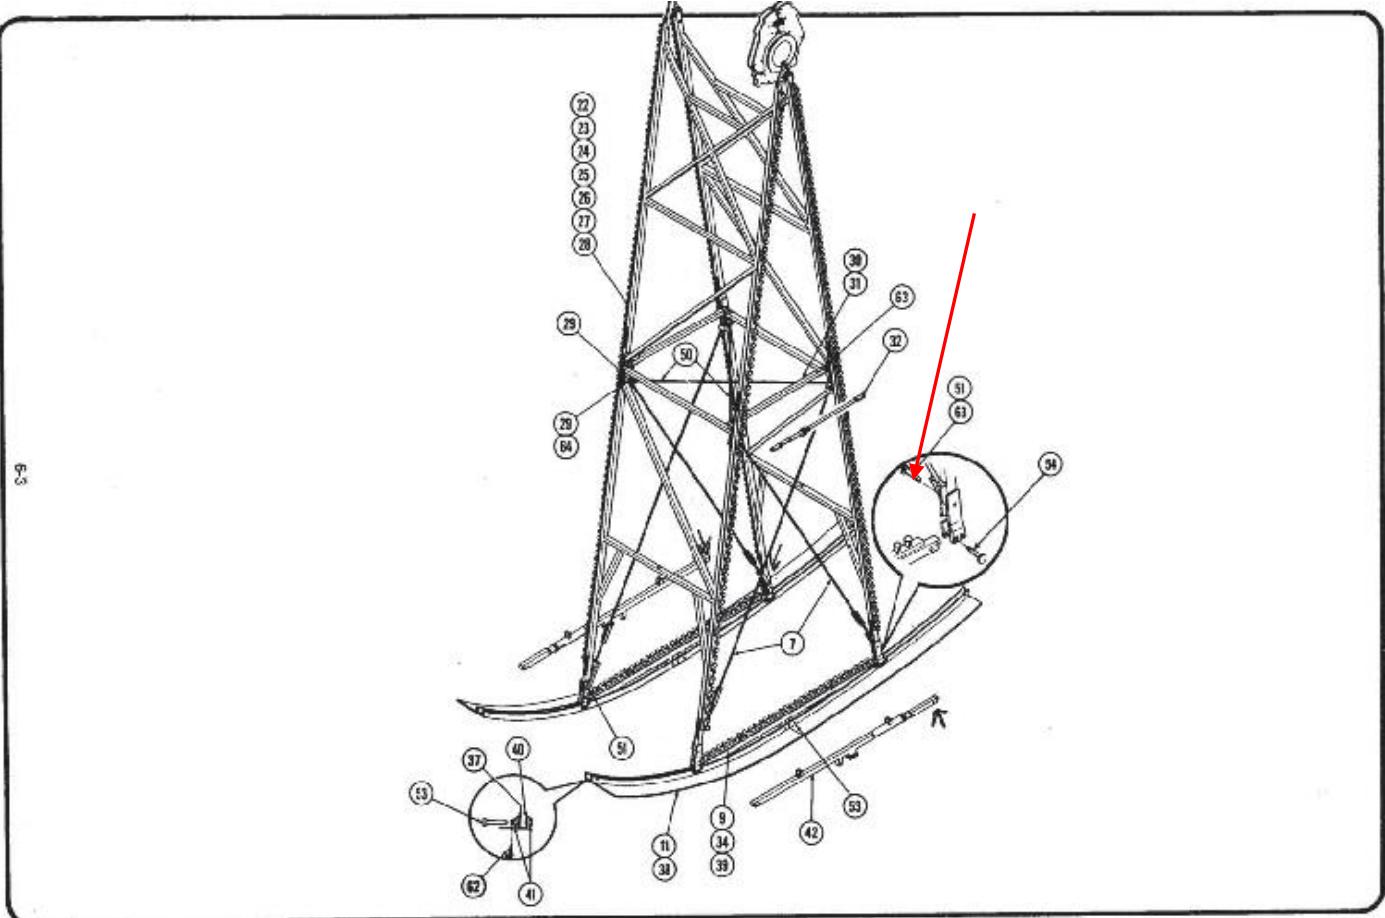
- Chance's owner's manual for the Wheel shows pin and Hairpin installation as follows, see **Illustration 1**.

Illustration 1 – Excerpt from Chance Wheel owner’s manual, the diagram depicts the proper installation of pins and Hairpins

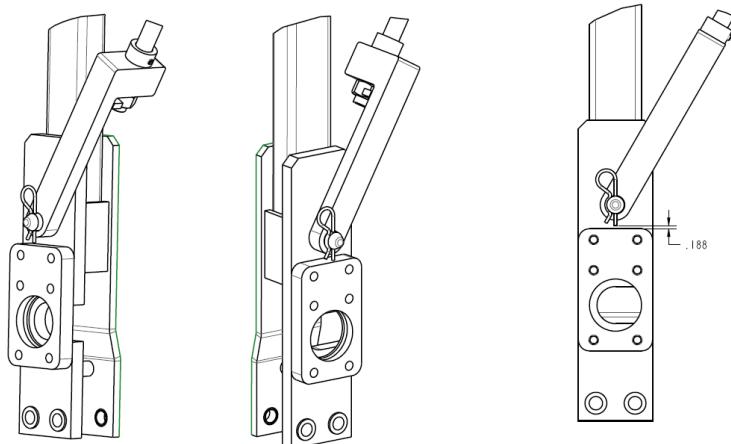
- The Department had ongoing communication with Chance and requested clarification on the proper pinning of the tie rod to the sweeps. **Illustration 2**, below, was received by the Department on October 1, 2019 from Chance. This depiction conflicts with the Chance Wheel owner’s manual, **Illustration 1**.

Illustration 2 – Chance’s initial depiction of proper pinning of the tie rods received by the Department on October 1, 2019. Note this diagram depicts the pins installed from the outside pointing inward

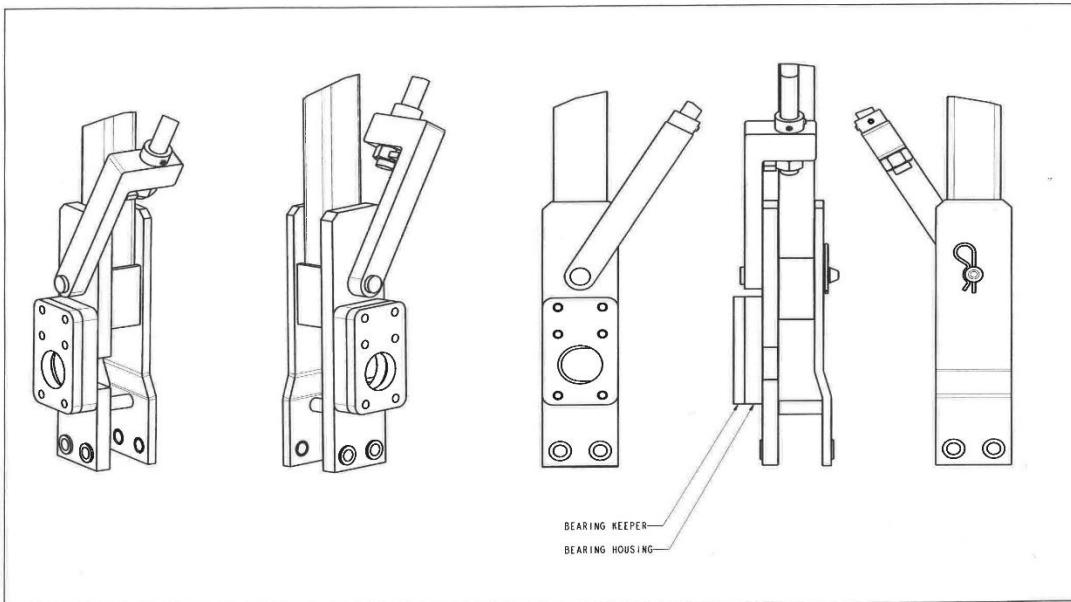
- The Department has gathered conflicting information from operators, experienced industry members and from Chance. Post-accident, representatives from Chance provided both pinning methodologies: one on October 1, 2019 (**Illustration 2**) and the most recent on October 10, 2019 (**Illustration 3**).

Illustration 3 – Chance's 2nd submission to the Department depicting the proper pinning of the tie rods received on October 10, 2019, note this diagram depicts the pins installed from the inside pointing outward
