**Project Overview:**

Red Rose Road was an extensive road rehabilitation project that was completed in 2001, with Driving Surface Aggregate placed on the road in 2002. This demonstration project was completed in cooperation with the Huntingdon County Conservation District, the Penn State Experimental Forest, and Barree Township.

## Red Rose 2: 2020 and 2022

## Camp Road: 2022

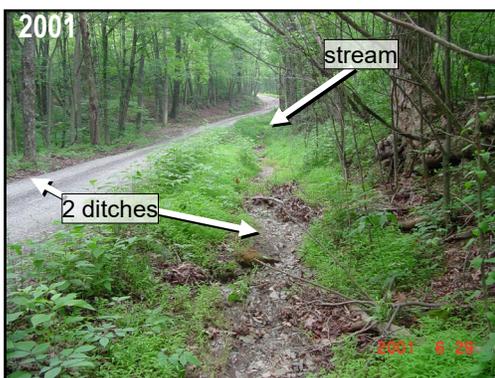
**BEFORE.** Entrenched road traps runoff in ditch, transporting it to stream. Heavy canopy and insufficient cover to install crosspipes.

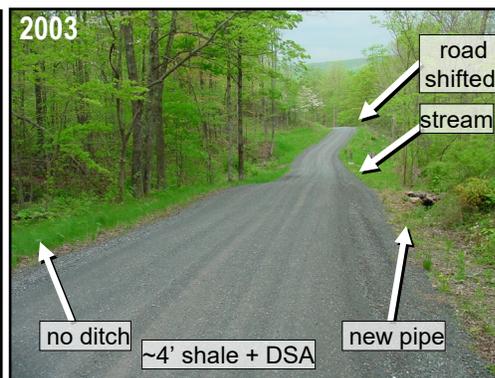
**AFTER.** Raised road eliminates left ditch, and provides cover for pipes to drain right ditch. Trees thinned and road shifted away from stream.

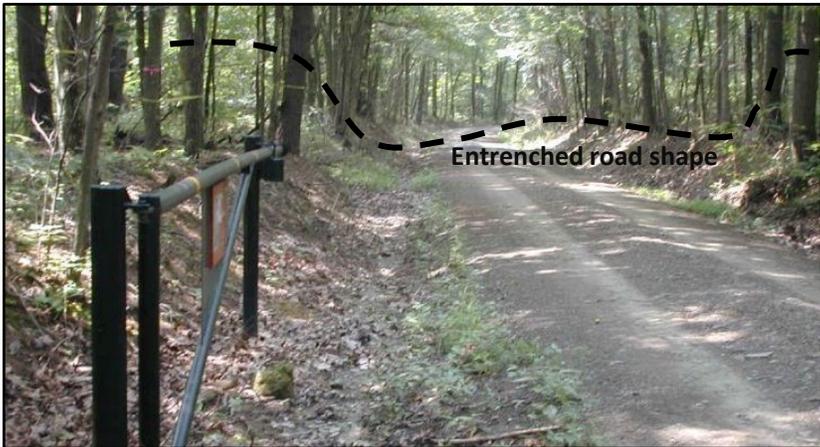
Statewide, the DGLVR Program utilizes over 300,000 tons of road fill a year, as illustrated in the graph below

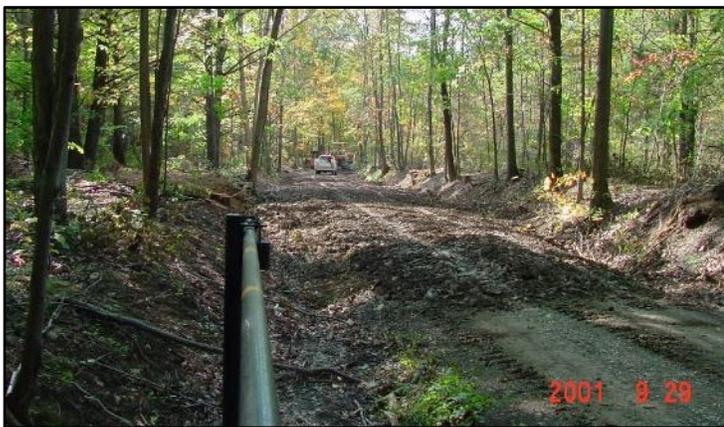
**During (2001):** Beginning to fill road with local shale.

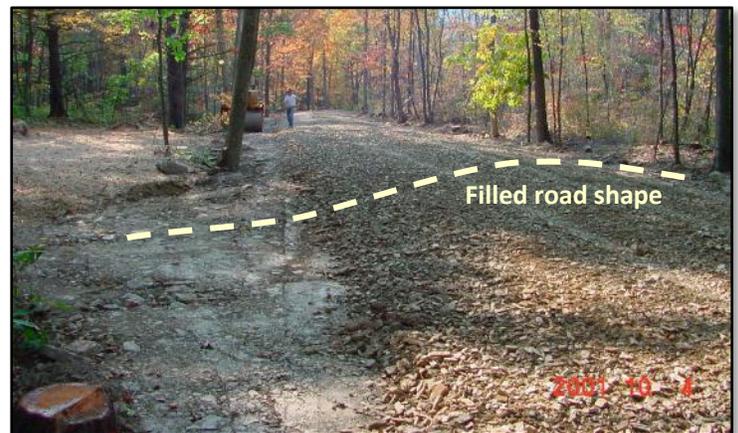
**During (2001):** Final road base elevation achieved.

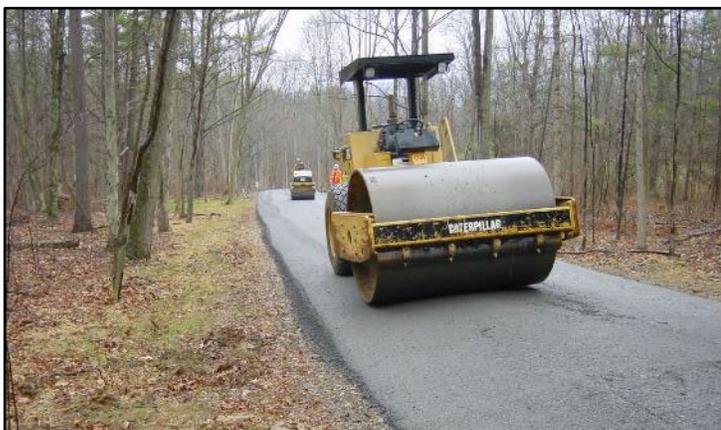
**During (2002):** Capping fill with DSA.

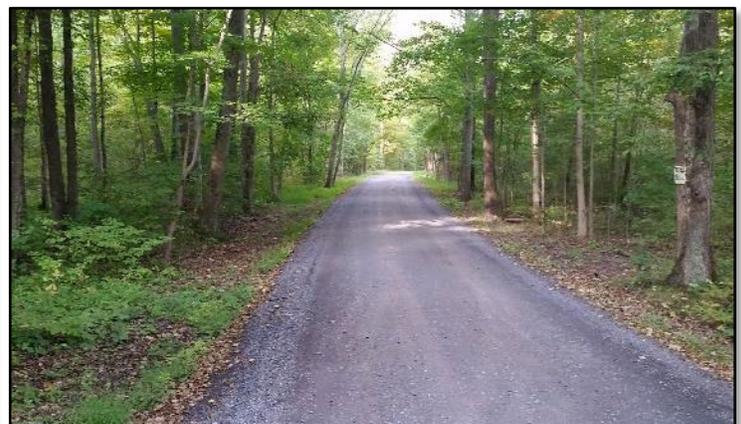
**2022:** Pipes and road fill still shed water.

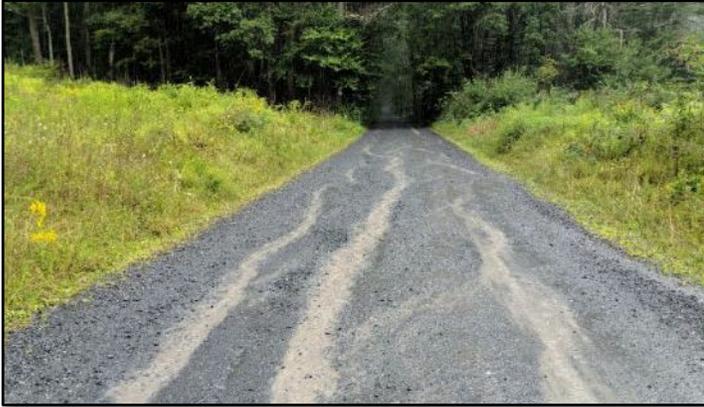
**Before (2020):** Entrenched road traps water on surface.

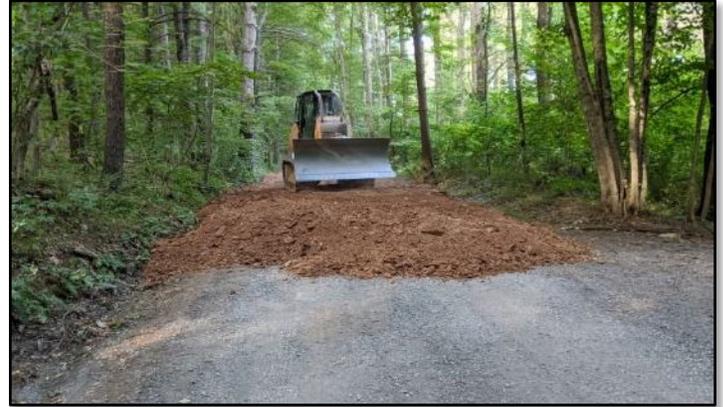
**During 1:** Adding shale in 12" lifts then compacting

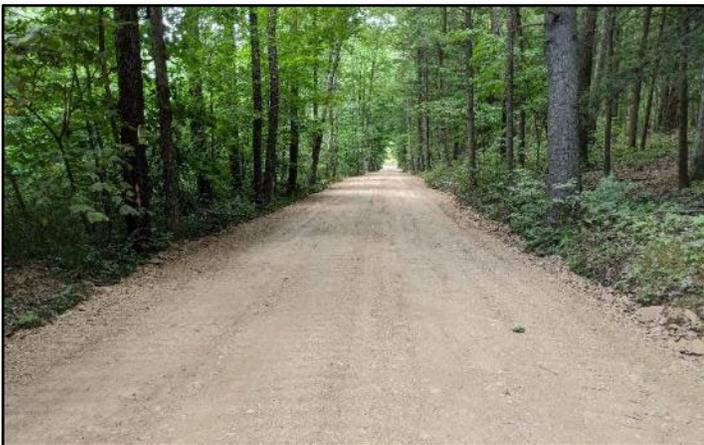
**During 2:** Compacted shale base ready for pipes and 2A.

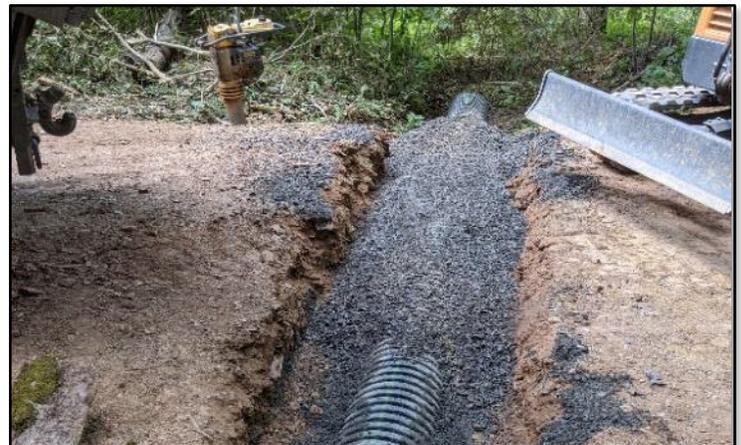
**During 3:** Installing shallow pipe in new shale.

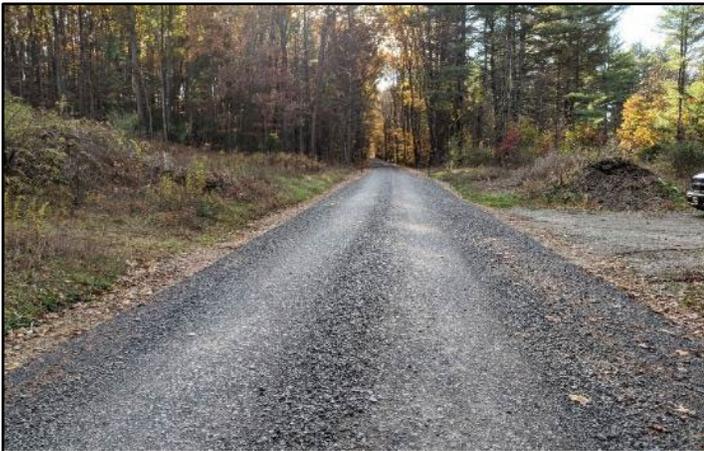
**After (2020):** Drainage complete, 2A surface.

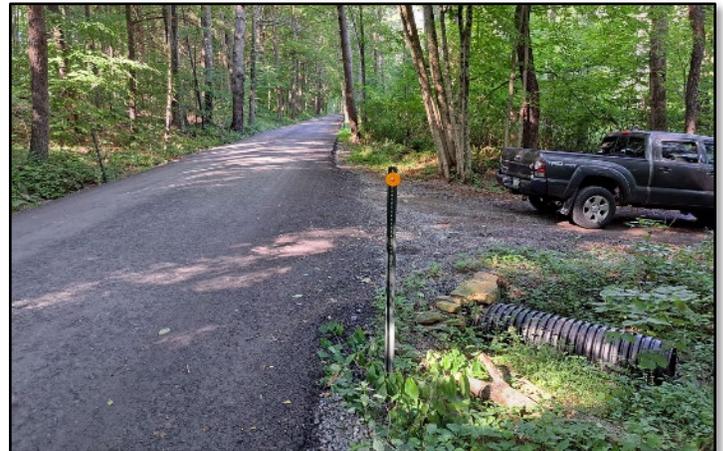
**2022:** New pipe below driveway, DSA surface.

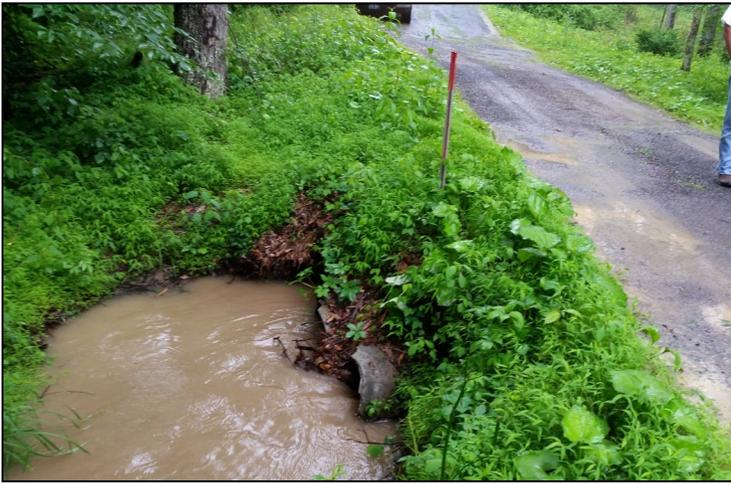
**Camp Road:** The twin 24' pipes in this stream were significantly undersized. They caused gravel bars to form upstream which required constant maintenance from the township. They were also prone to plugging in this 100% forested watershed, causing the stream to overtop and wash out the road.

**Before:** Twin 24" pipes were severely undersized for this 7' channel causing a host of issues.

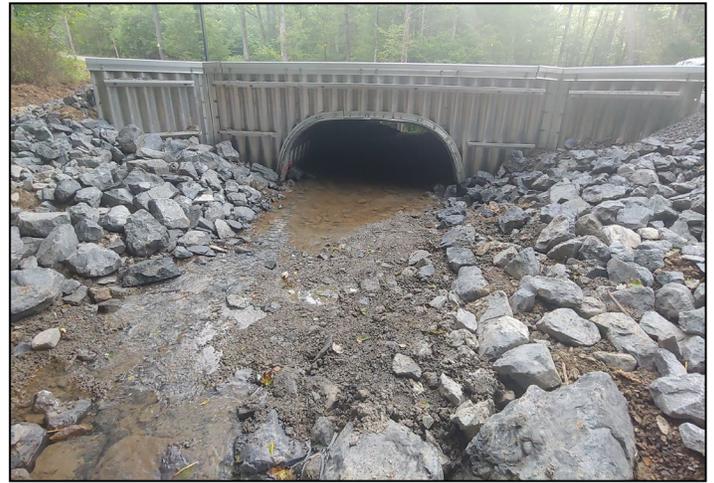
**After:** A 10' wide by 5' high plate arch is buried ~18" deep into the stream channel.
